HIGH MISALIGNMENT CARBON SEALS FOR THE FAN DRIVE GEAR SYSTEM TECHNOLOGIES

Dennis Shaughnessy and Lou Dobek
United Technologies—Pratt & Whitney
East Hartford, Connecticut

2005 NASA Seal/Secondary Air Delivery Workshop

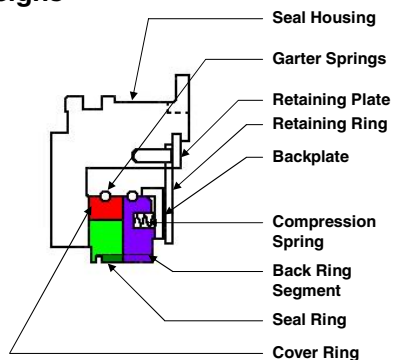
3-Piece Segmented Circumferential (Advanced Design)

Baseline seal was composed of a one-piece 4 segmented seal. Alternate design is composed of a three-piece design, each piece consisting of four segments.

- Carbon X repeatedly exceeds 100 hour wear limit.
1. Excessive coking indicated negative wear.
 2. Test terminated after two attempts resulted in broken seal segments.

- All components using Carbon Y meets the 100 hour wear limit in Radial misalignment tests.
- Carbon Y components exceed 100 hour wear limit in axial misalignment tests. Mounting hardware damage identified.

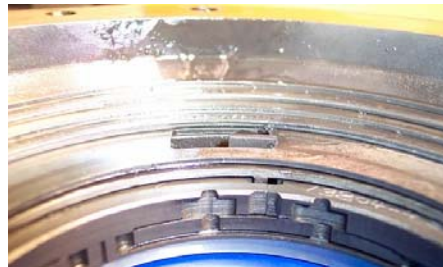
Seal Assembly

Backplate Tab Failure

Seal Ring Notch Wear

Back Ring Tab Failure

Photos of the seal assembly and signs of wear that occurred during misalignment testing.

Backplate stress crack identified after test with the largest combination of Radial and Angular misalignment. Modification increased the corner radii at the keys.

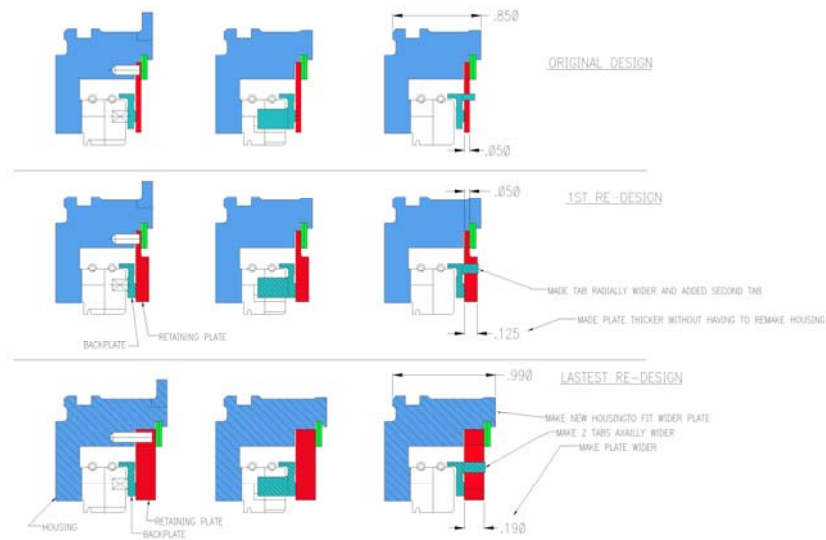
Sections through the test seal illustrate the original design, modifications made during the phase 3 test program and the latest re-design for the current tests phase.
